# Durability Guaranteed

Pulhamite rockwork –  
Its conservation and repair

ENGLISH HERITAGE

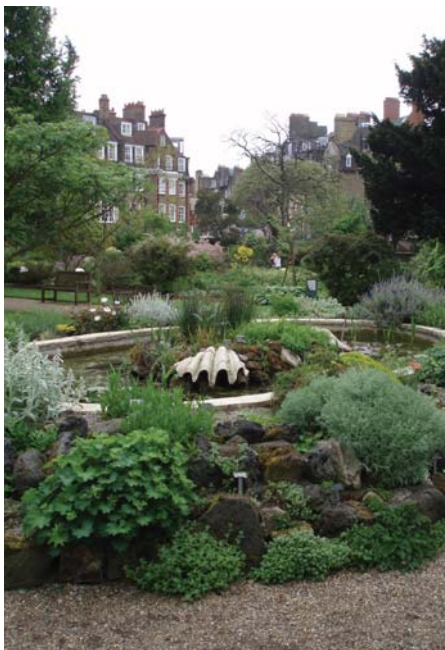
**Fig 1** The Chelsea Physic Garden rockery was made from volcanic stone from Mt Heccia in Iceland (brought back by Joseph Banks in 1772) and rubble from the Tower of London. It is probably the first rockery in Europe built for the purpose of displaying plants. (© EH/Ben Simpkins)

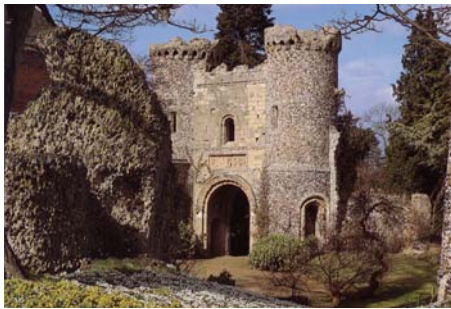
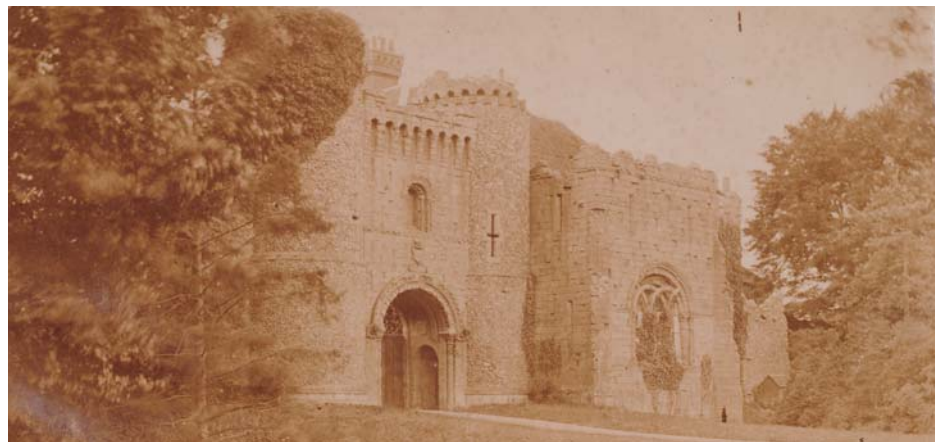
Fig 7a,b Contemporary and historic views of the Benington Lordship gatehouse showing the stone dressings modelled in cement to look like weathered cubical ashlar. (© Benington Lordship/A F Kersting; © RHS, Lindley Library (from Pulham c1877)).

In 1834 Pulham established his own business premises in Tottenham. Four years later, he had completed a mock-Norman castle, replete with artificial stone dressings and mouldings, for the Proctor family at Benington Lordship, Hertfordshire.

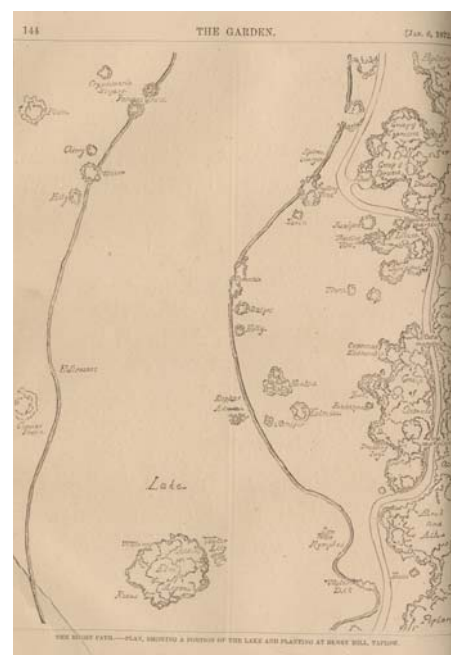
**Fig 17** The planting plan for Berry Hill, Taplow. (© RHS, Lindley Library)

A plan of Berry Hill published in *The Garden* (Anon 1872) shows a lake with an island, a sinuous path and a seat. Trees and shrubs — typical of the Pulhams' planting in that period — include elm, cherry, holly, willow, copper beech, tamarisk, heaths, juniper, *Kalmia*, spruce, deodar, *Cupressus* species, lilac, *Hypericum*, *Vinca*, ivy, chestnut, birch, ash, yew, poplar and oak, plus bullrushes and water lilies.

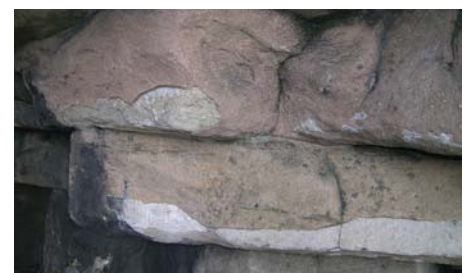
Fig 20a Loss of surface render (© J Stewart)

- Detachment of the render as a result of: inadequate keying of surfaces and poor application; a weak backing or undercoat layer; shear stresses from structural failure; water ingress and frost action; or re-crystallisation of soluble salts (from poorly selected core materials such as marine shingle or sand; from bricks with a high salt content; from rainwater or groundwater; or from cleaning or plant-control chemicals);
- Cracks resulting from: an excessively strong render mix (for example, too rich in cement) on a weaker backing; drying shrinkage; root damage or structural failure; small cracks (less than about 3mm wide) or crazing may also arise from poorly graded aggregate;

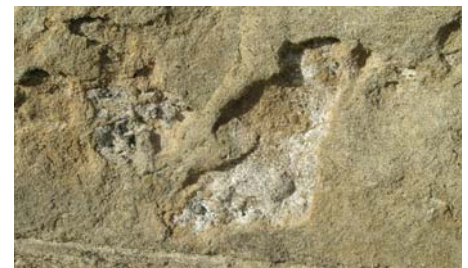
Fig 20b Salt efflorescence (© J Stewart)

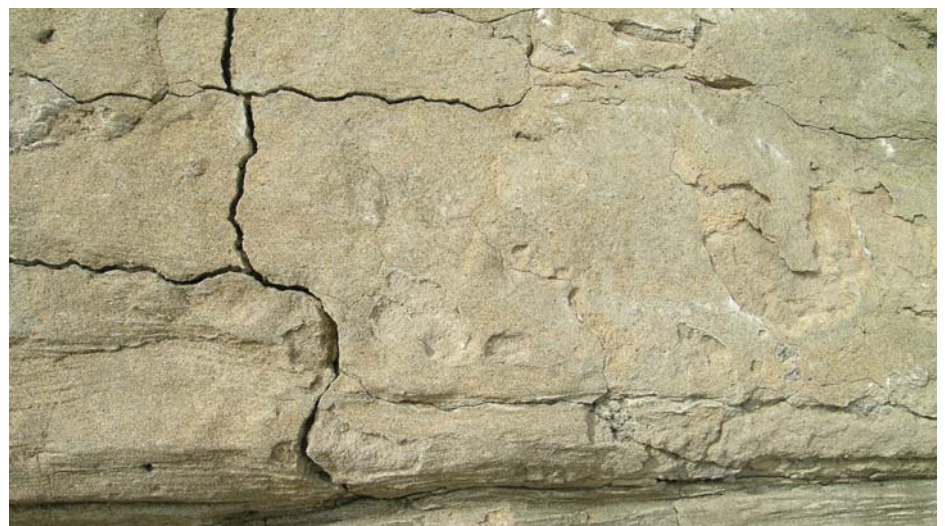
Fig 20c Network cracking (© J Stewart)

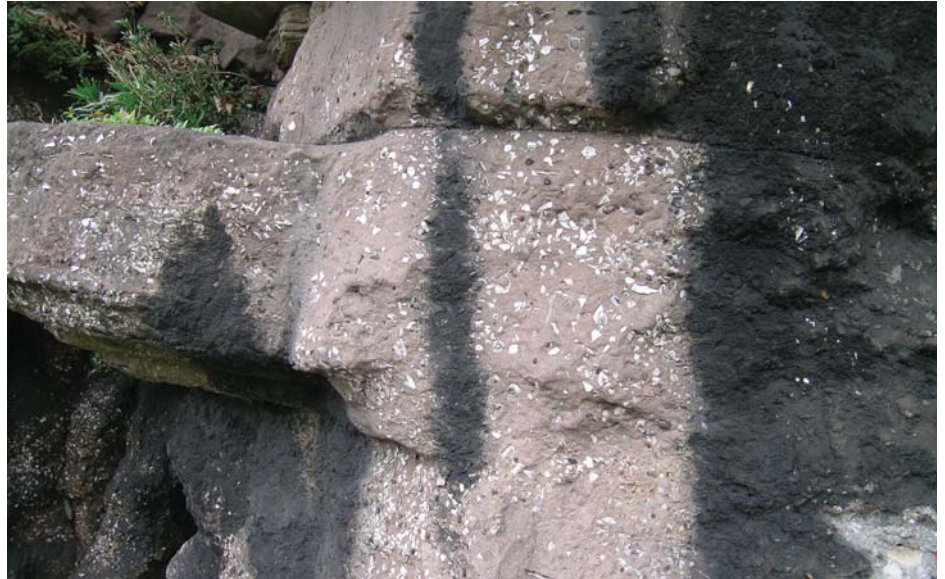
Fig 21a Sulphation of surface (areas unwashed by rain) (© J Stewart)

- Spalling, granulation or blistering due to: deterioration or weathering of the cement binder; frost action; sulphation of lime binders (transformed by certain water borne sulphur compounds into partially soluble calcium sulphate); or the action of other soluble salts;
- Loss of surface detail or texture or the exposure of backing material, due to physical erosion from wind and rain, combined with chemical erosion;
- Black sulphate crusts on sheltered surfaces, an effect of atmospheric pollution which is occasionally associated with the detachment of sulphate-rich render layers;
- Staining due to iron or copper fixtures, organic matter or micro-organisms, or from unsuitable repairs;
- Vandalism, including graffiti.

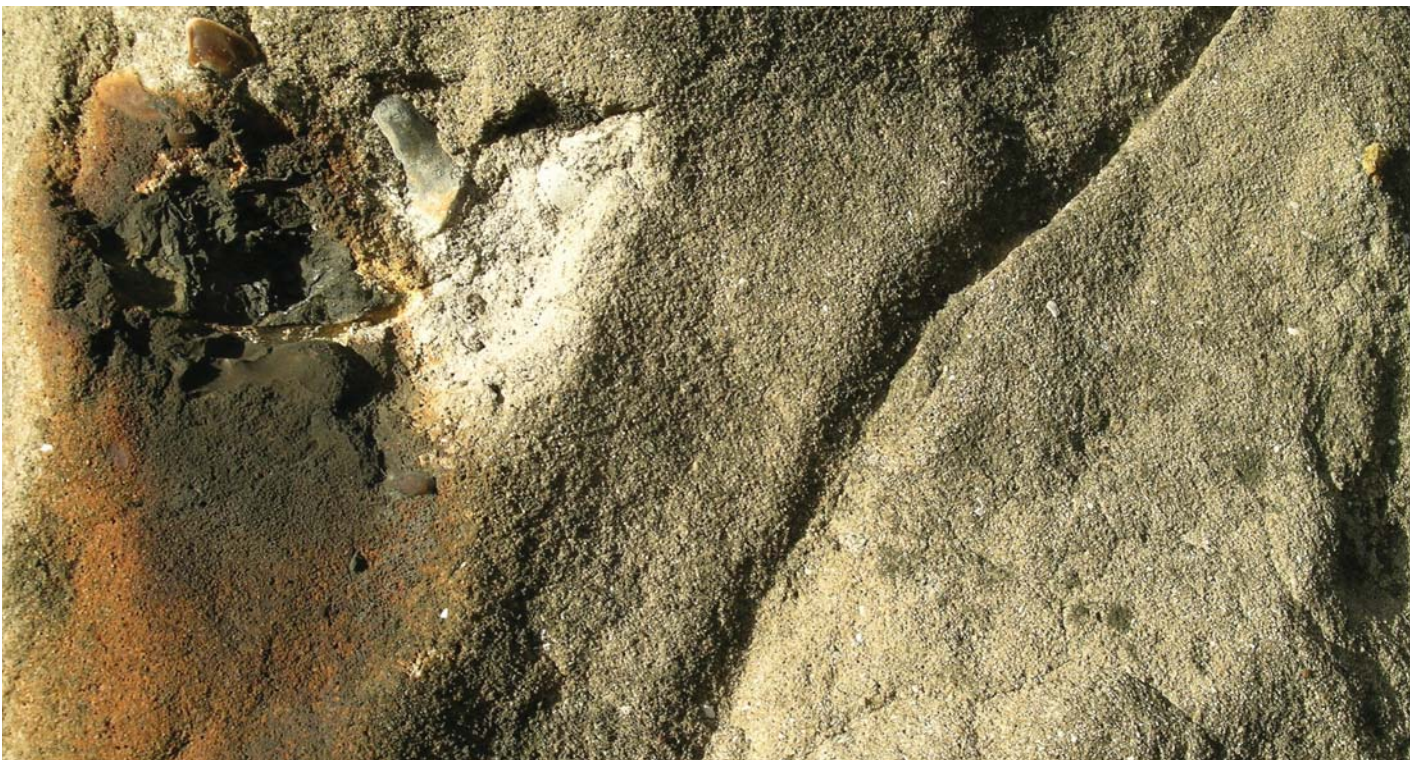
Fig 21b Surface staining caused by iron corrosion (© J Stewart)

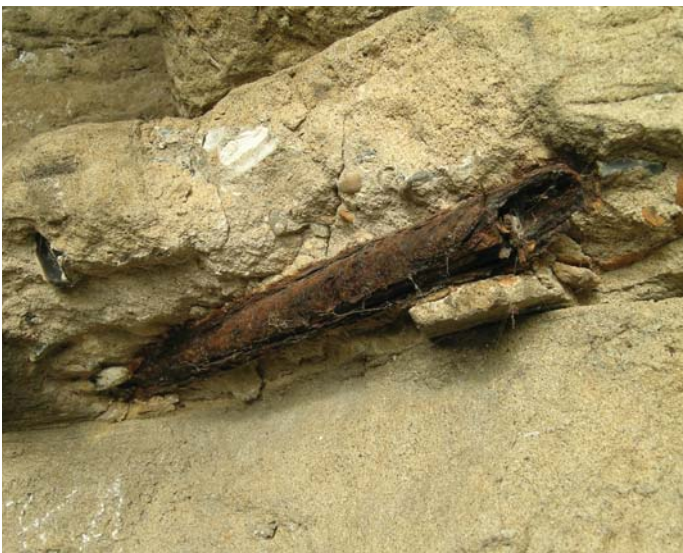
Fig 21c Iron corrosion and disruption of surface render (© J Stewart)

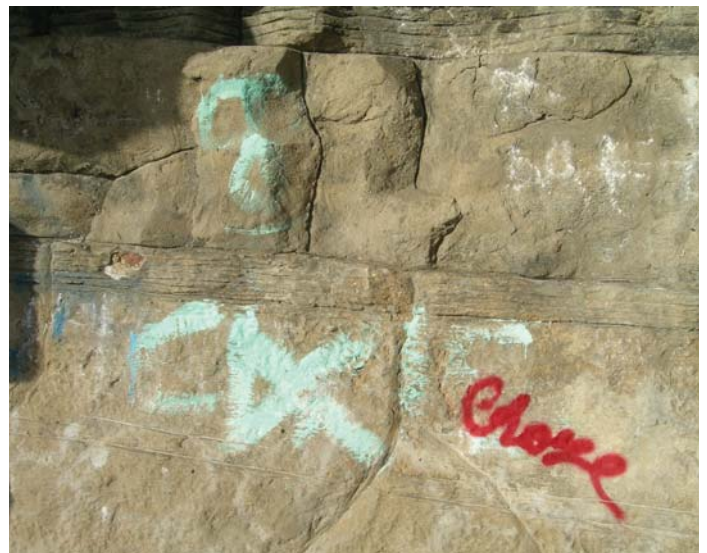
Fig 21d Cumulative graffiti (© J Stewart)

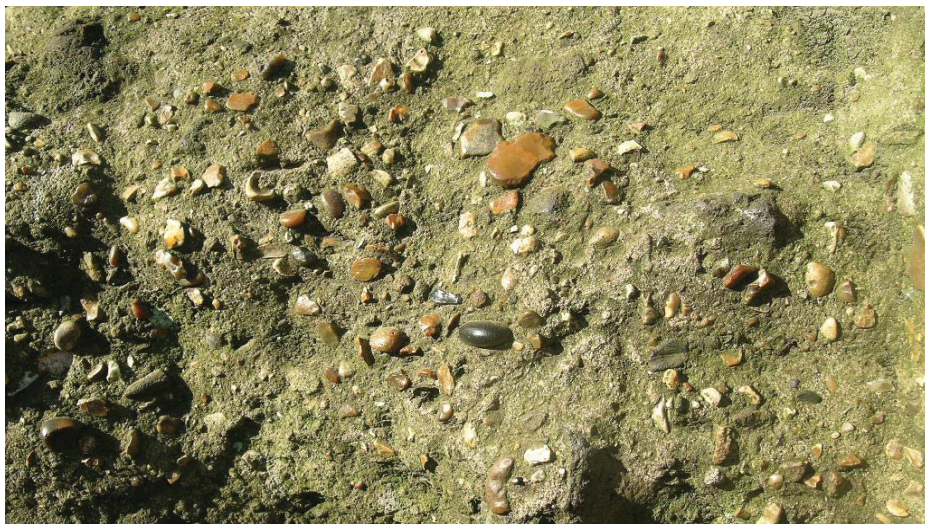
Fig 22a Weathered surface with exposure of aggregate (© J Stewart)

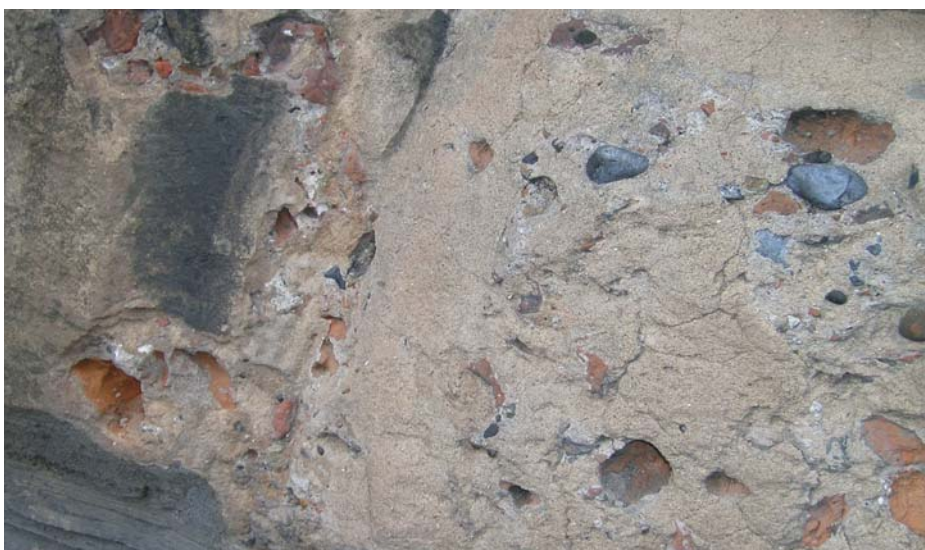
Fig 22b Erosion of structural core, preferential erosion of soft brick in the core (© J Stewart)

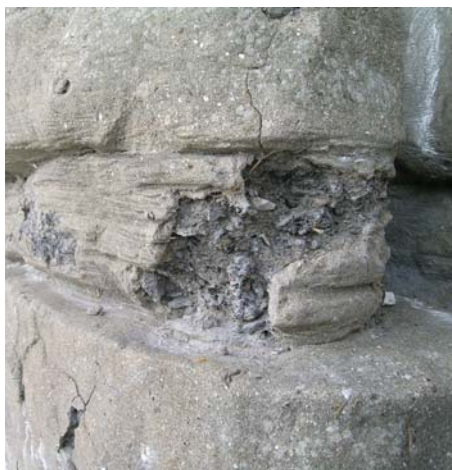
Fig 22c Erosion of structural core, loss of mortar and aggregate matrix (© J Stewart)

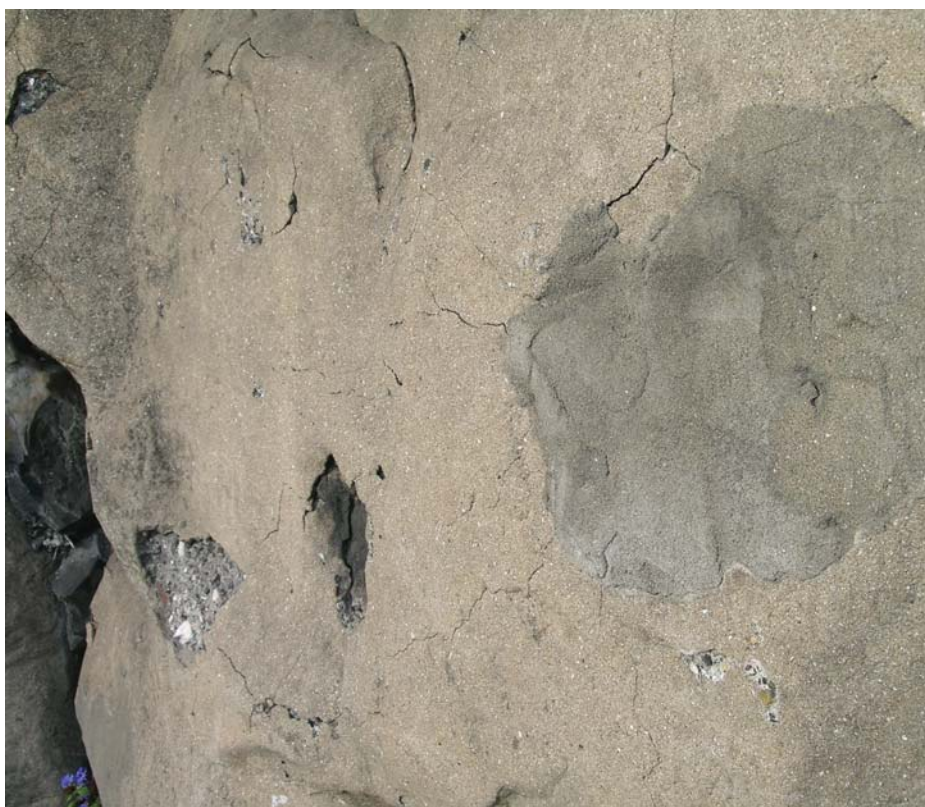
Fig 22d Surface repair distinct from original material (© J Stewart)

Some surface repairs can be distinguished from the original render owing to the custom of scraping back a partially set render coat, drawing out aggregate particles and creating a pitted finish on the surface of the repair. This differs from the granulated finish of weathered Pulhamite in which aggregate particles stand proud of the surface.

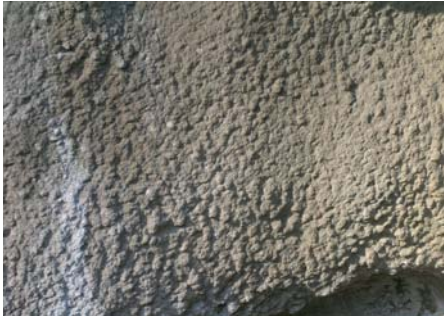
**Fig 22e** Surface covered with Gunnite (© J Stewart)

The repair of rendered surfaces at some sites has been carried out using gunnite, a Portland cement-based slurry adapted for spray application. This is particularly disfiguring, obscuring original colouration and texture, which were invariably applied with some sophistication. Gunnite mixes may contain bonding agents or other admixtures to improve adhesion or water repellency, and are impossible to remove without damage to the underlying material. Although the underlying render may itself be quite impermeable, this type of repair makes inspection of the substrate more difficult, and may cause other damage.

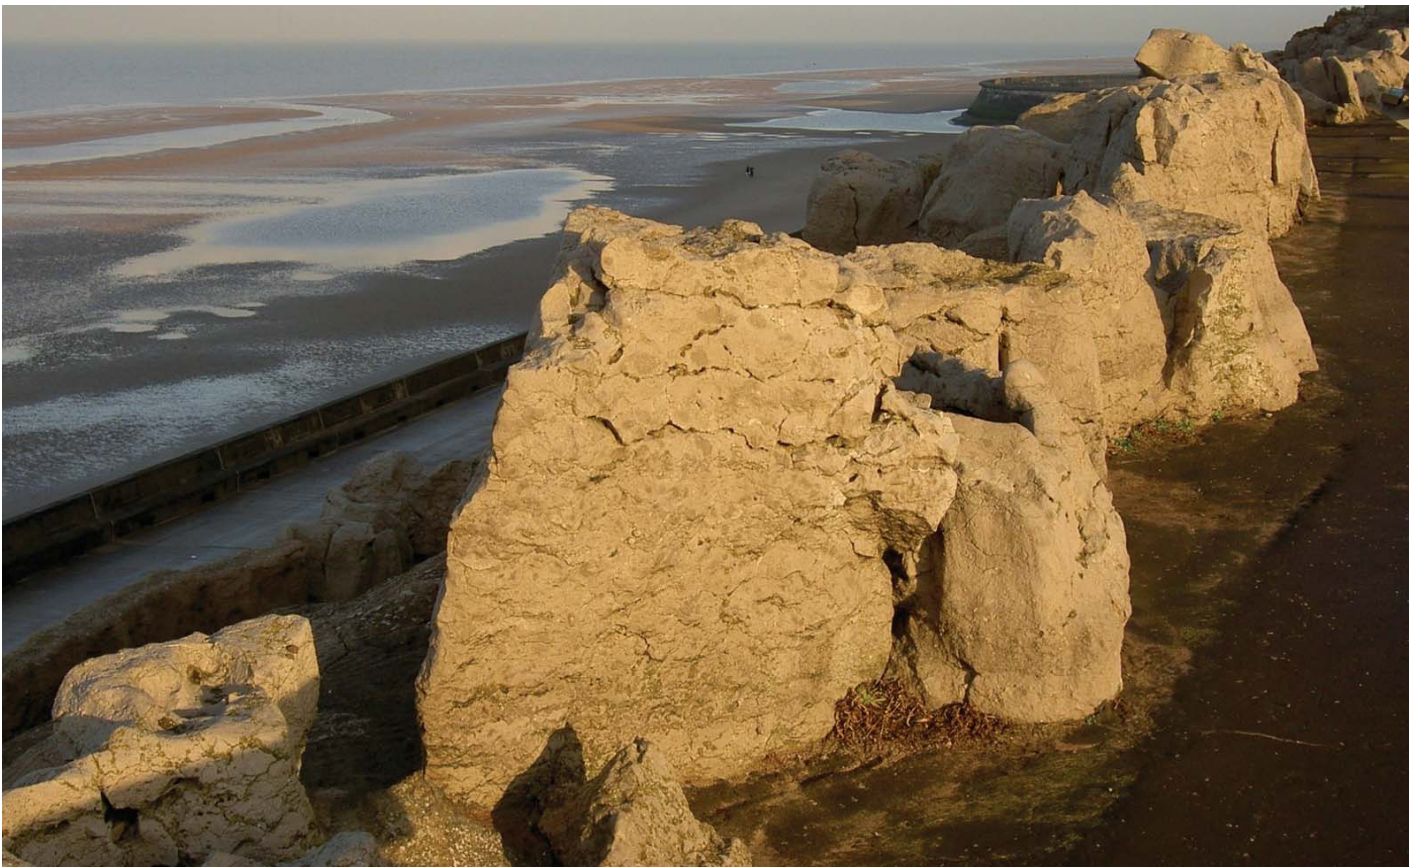
**Fig 23** James Pulham & Son were commissioned to 'rockify' the northern Blackpool seafront in the 1920s. The rockwork has since been sealed with a cement-based slurry. (© EH/Jennifer White)

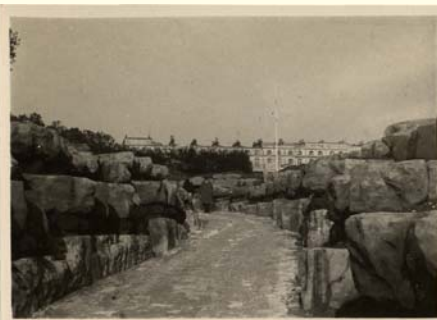
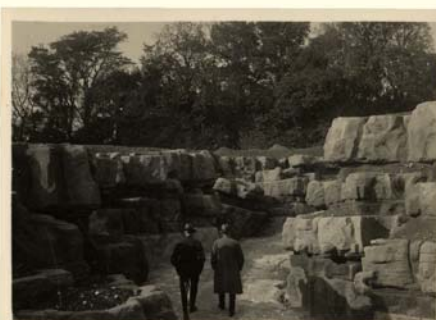
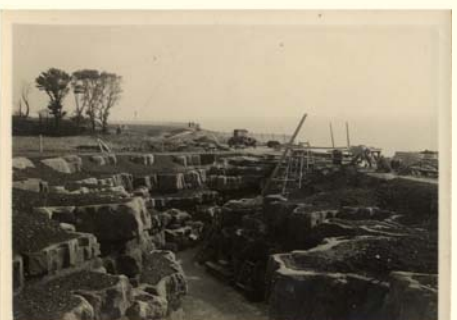
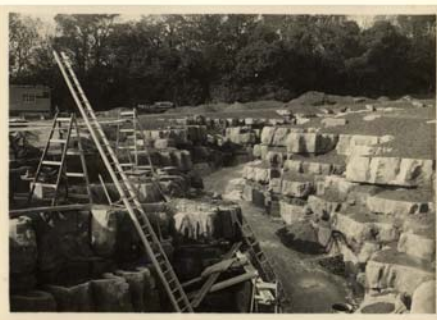
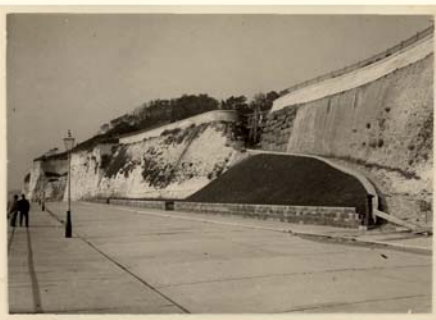
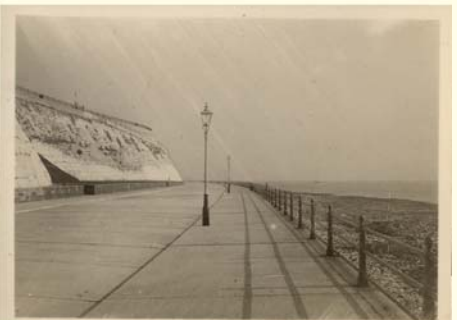
**Fig 24** Photographs of Pulhamite rockwork being constructed at Ramsgate. (© East Kent Archives Centre)

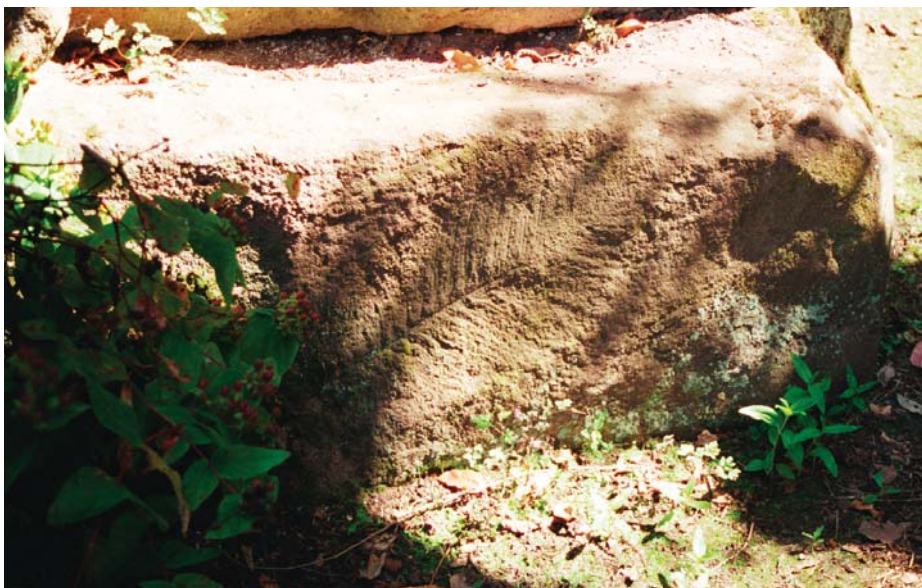
**Fig 27** Pulham detailing may include features such as this leaf imprint, or a buried shell. (© Simon Swann)
